# Inspection Report

**Property Address:**

552 Brindway  
Raleigh NC

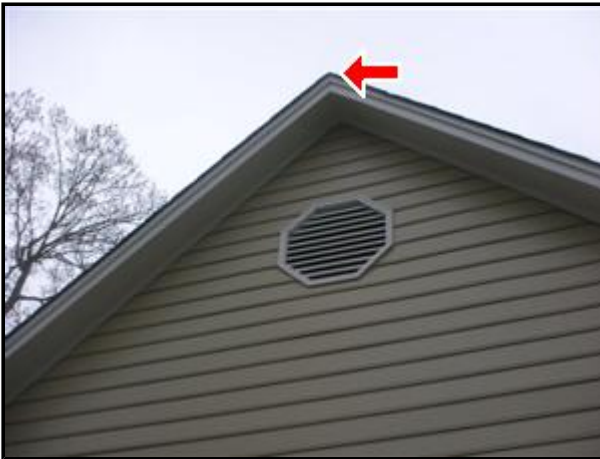
1. **Repair** Ridge cap shingles are torn at the following gable end(s): left end; front over garage.

Item 1 - Picture 1 Torn ridge shingle at front of garage

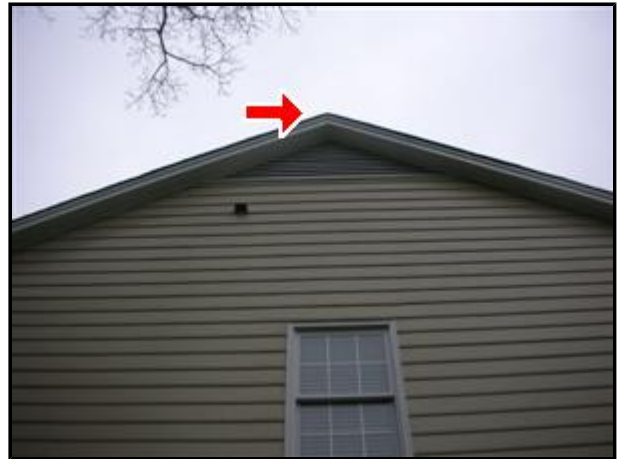
Item 1 - Picture 2 Torn ridge shingle at left gable end

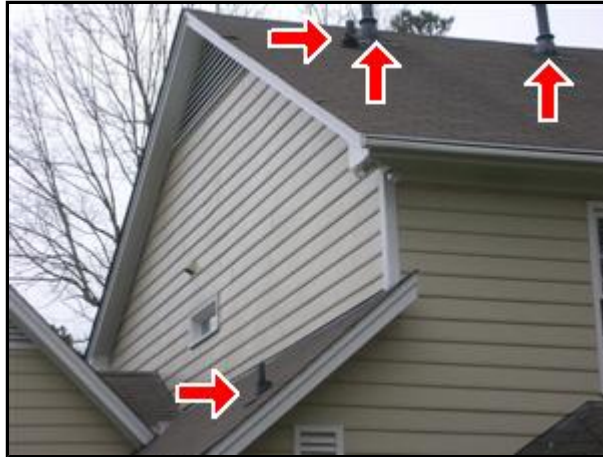
2. **Repair** Two plumbing vent flashings are torn or split, open to leakage. Another has been repaired. Damaged plumbing vent flashings should be replaced to prevent leakage. Also, there are water stains in the attic under where two of the gas vents penetrate the roof, suggesting leakage. Seal gas vent flashings as needed to prevent leakage.

Item 2 - Picture 1 Examples of plumbing vent and gas vent roof penetrations

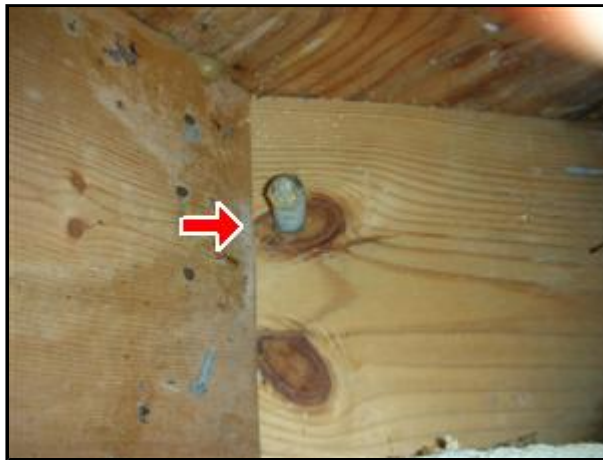
5. (1) **Repair** The deck is bolted to the house. However, some of the deck bolts lack nuts, so they are not secured. Replace missing bolts.

Item 5 - Picture 1 Example of missing bolt

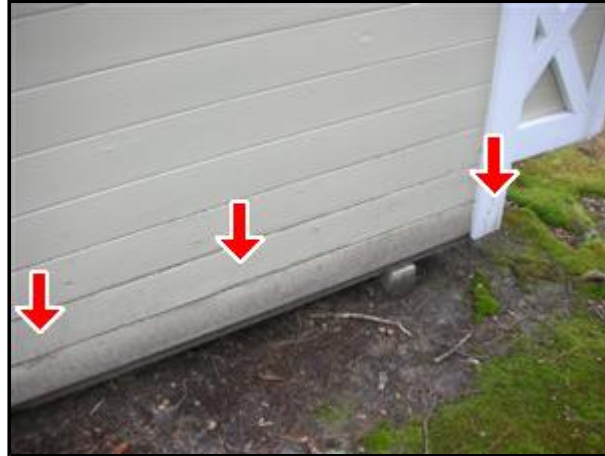
7. **Repair** Detached shed: small areas of siding are decayed on the left and rear walls, and the left front cornerboard is decayed. The left door casing has come loose from the wall, so the door does not hang properly. Maintenance recommendation: after these items are repaired caulk any open joints between pieces of siding to reduce chances of water infiltration.

Item 7 - Picture 1 Examples of damaged areas

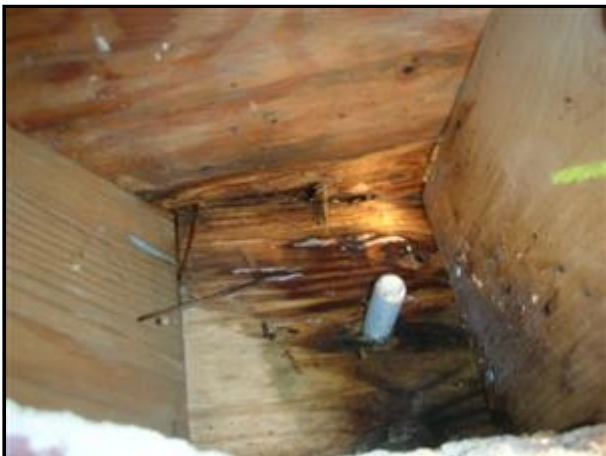
9. **Repair** There is minor structural damage to the floor system under the corners of the back door. The wood in these areas is wet, indicating active water penetration. The back door jambs are decayed. A qualified contractor should repair as needed to correct water penetration and replace damaged materials.

Item 9 - Picture 1 Example of floor system damage

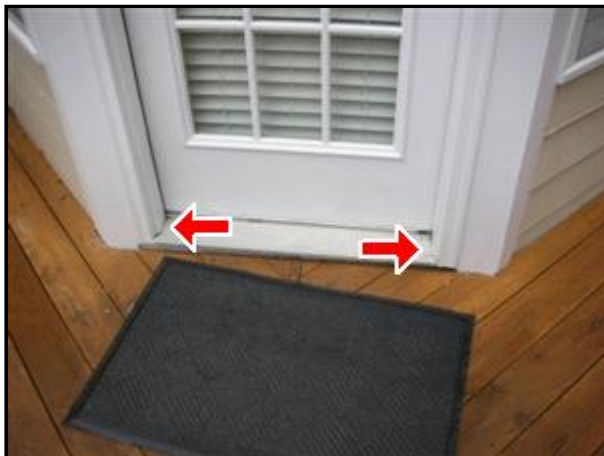
Item 9 - Picture 2 Damaged door jambs

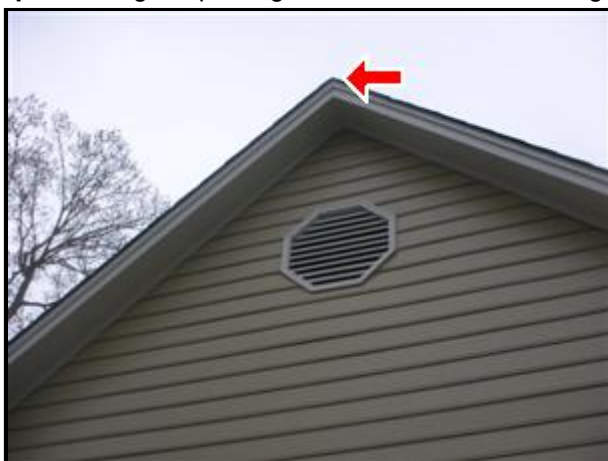
**Repair** Ridge cap shingles are torn at the following gable end(s): left end; front over garage.

1.0 Picture 1 Torn ridge shingle at front of garage

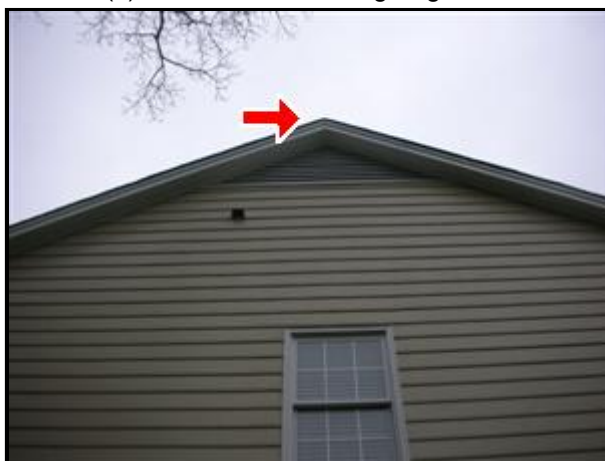
1.0 Picture 2 Torn ridge shingle at left gable end

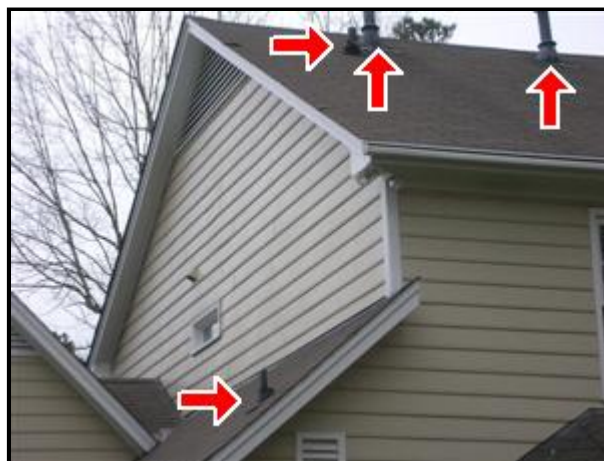
**Repair** Two plumbing vent flashings are torn or split, open to leakage. Another has been repaired. Damaged plumbing vent flashings should be replaced to prevent leakage. Also, there are water stains in the attic under where two of the gas vents penetrate the roof, suggesting leakage. Seal gas vent flashings as needed to prevent leakage.

1.1 Picture 1 Examples of plumbing vent and gas vent roof penetrations

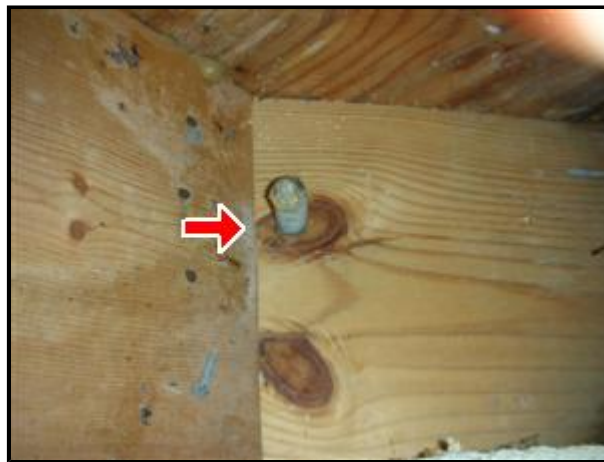
(1) **Repair** The deck is bolted to the house. However, some of the deck bolts lack nuts, so they are not secured. Replace missing bolts.

2.3 Picture 1 Example of missing bolt

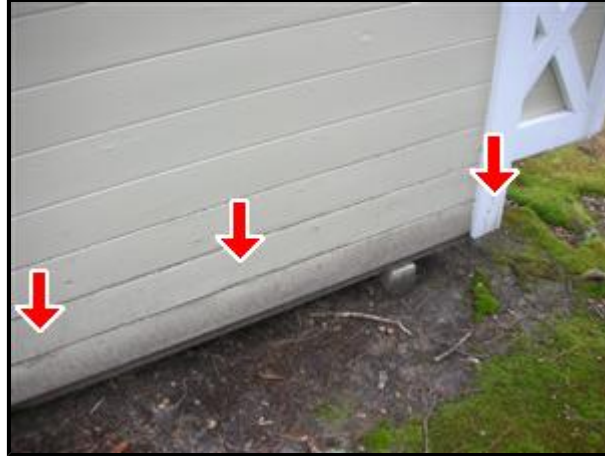
**Repair** Detached shed: small areas of siding are decayed on the left and rear walls, and the left front cornerboard is decayed. The left door casing has come loose from the wall, so the door does not hang

2.6 Picture 1 Examples of damaged areas

properly. Maintenance recommendation: after these items are repaired caulk any open joints between pieces of siding to reduce chances of water infiltration.

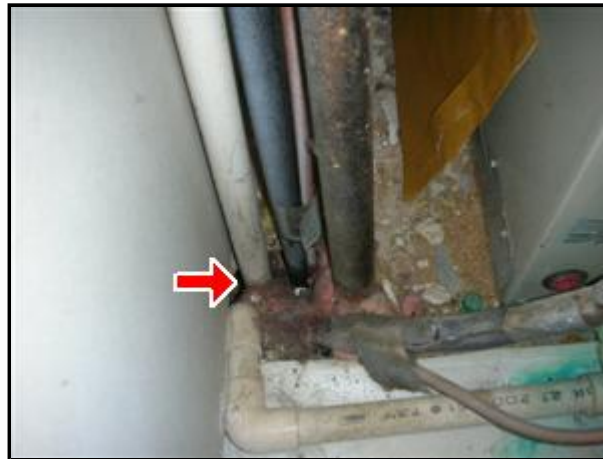
3.2 Picture 1 Gaps to be sealed

**Maintenance** Seal gaps open to crawl space in furnace closet floor where pipes pass through the floor. Be sure to leave the screened openings to the crawl space and attic open as these are necessary to provide combustion air to the furnace.

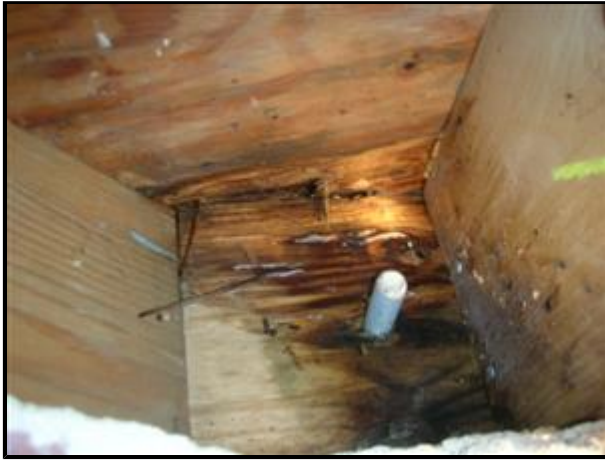
**Repair** There is minor structural damage to the floor system under the corners of the back door. The wood in these areas is wet, indicating active water penetration. The back door jambs are decayed. A qualified contractor should repair as needed to correct water penetration and replace damaged materials.

4.3 Picture 1 Example of floor system damage

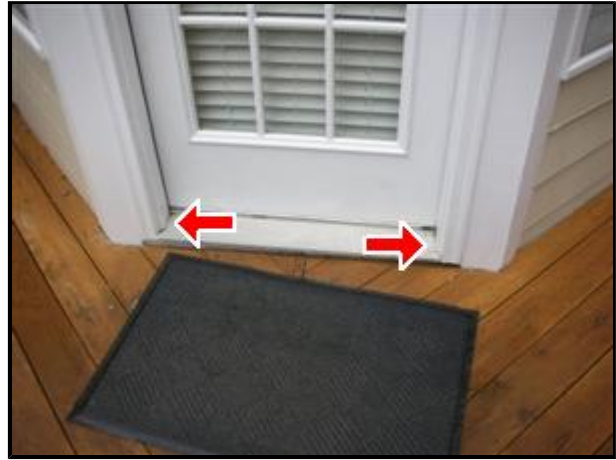
4.3 Picture 2 Damaged door jambs
